DEPARTMENT OF TRANSPORTATION

Office of Structural Materials

Contract #: 04-0120F4Cty: SF/ALA Rte: 80 PM: 13.2/13.9File #: 69.28**WELDING INSPECTION REPORT****Resident Engineer:**Siegenthaler, Peter**Address:** 333 Burma Road**City:** Oakland, CA 94607**Report No:** WIR-018086**Date Inspected:** 13-Nov-2010**Project Name:** SAS Superstructure**OSM Arrival Time:** 645**Prime Contractor:** American Bridge/Fluor Enterprises, a JV**OSM Departure Time:** 1845**Contractor:** Zhenhua Port Machinery Company, Ltd (ZPMC), Changxing Island **Location:** Shanghai, China**CWI Name:** Wang Li Yang.**CWI Present:** Yes No**Inspected CWI report:** Yes No N/A**Rod Oven in Use:** Yes No N/A**Electrode to specification:** Yes No N/A**Weld Procedures Followed:** Yes No N/A**Qualified Welders:** Yes No N/A**Verified Joint Fit-up:** Yes No N/A**Approved Drawings:** Yes No N/A**Approved WPS:** Yes No N/A**Delayed / Cancelled:** Yes No N/A**Bridge No:** 34-0006**Component:** Orthotropic Box Girder(OBG)**Summary of Items Observed:**

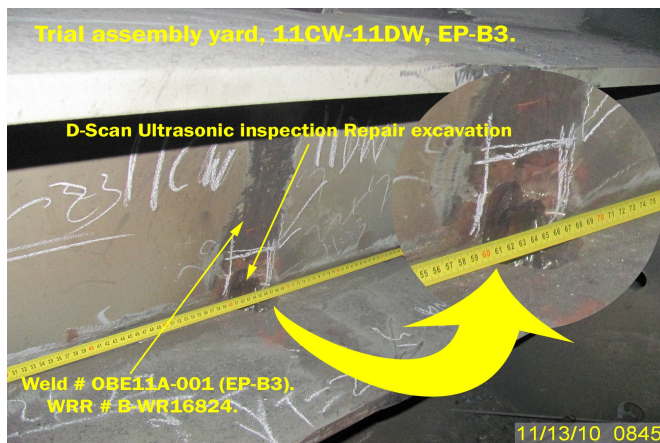
During Random Visual in process Inspection, this QA inspector observed repair excavation done on Transverse splice of Edge panels at intersection of OBG segment 11CW-11DW. The weld is identified as OBE11A-001 (EP-B3). This excavation was done according to AB/F-“D” scan Ultrasonic Inspection Report “UT-11W-057”. This QA inspector measured size of excavation. Excavation was 150mm in length, 55mm wide & 15mm deep. Excavation is located at 430mm from W1 side (SP-EP Weld) of the weld. ZPMC have prepared Weld repair report for this repair WRR # B-WR16824. The attached photographs provide additional detail.
